NASA TECHNICAL
MEMORANDUM

NASA TM X-64788

ATM C&D PANEL/EREP COOLING SYSTEM
CONTAMINATION PROBLEM

By James G. Williamson
Astronautics Laboratory

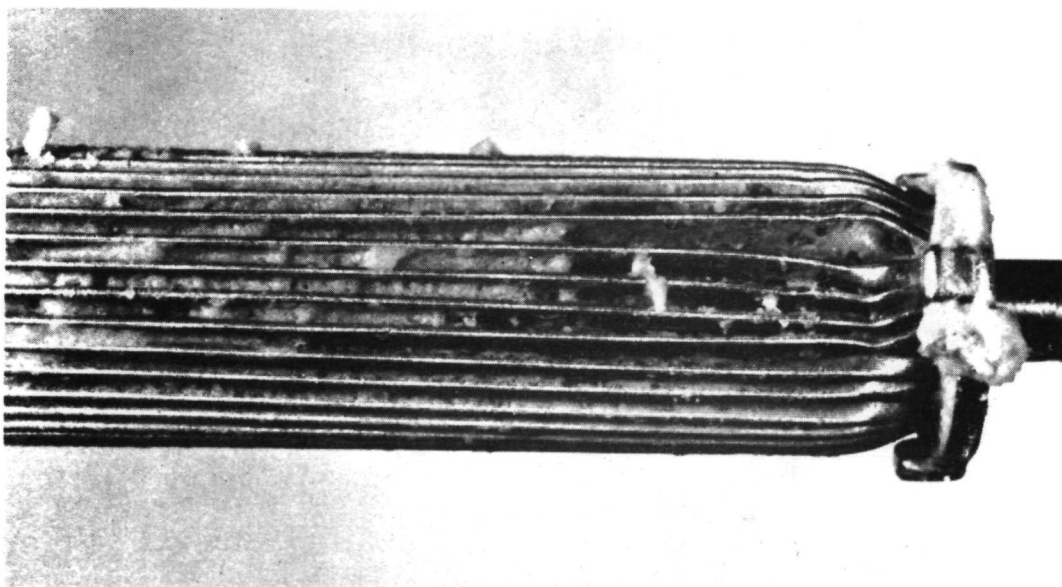
The replacement filter (S/N 24) was installed in the system and was subjected to only 35 hours of system operation during a five week period. The filter was examined and found to be about 80% covered with contaminants. It was estimated that the weight of the contaminants was from 2 to 5 grams. The contaminants on the filter did not cause a pressure drop nor was the flow restricted in any way.

KSC removed some of the contamination from the filter and sent the remainder to MDAC-E for a more complete analysis. Figure 3 shows the condition of the filter when it reached MDAC-E. Results of this analytical work indicated that the contamination was composed of metal phosphates, primarily aluminum and potassium. Minor components of the contamination may have included oxides or hydroxides, although this was not verified. Material Division personnel were present during the analytical study of the contamination at MDAC-E. The details of the finding of the analytical work on the contamination are given in Appendix II.

FIGURE 3 - CONTAMINATED FILTER S/N 24 (SOME MATERIAL REMOVED)

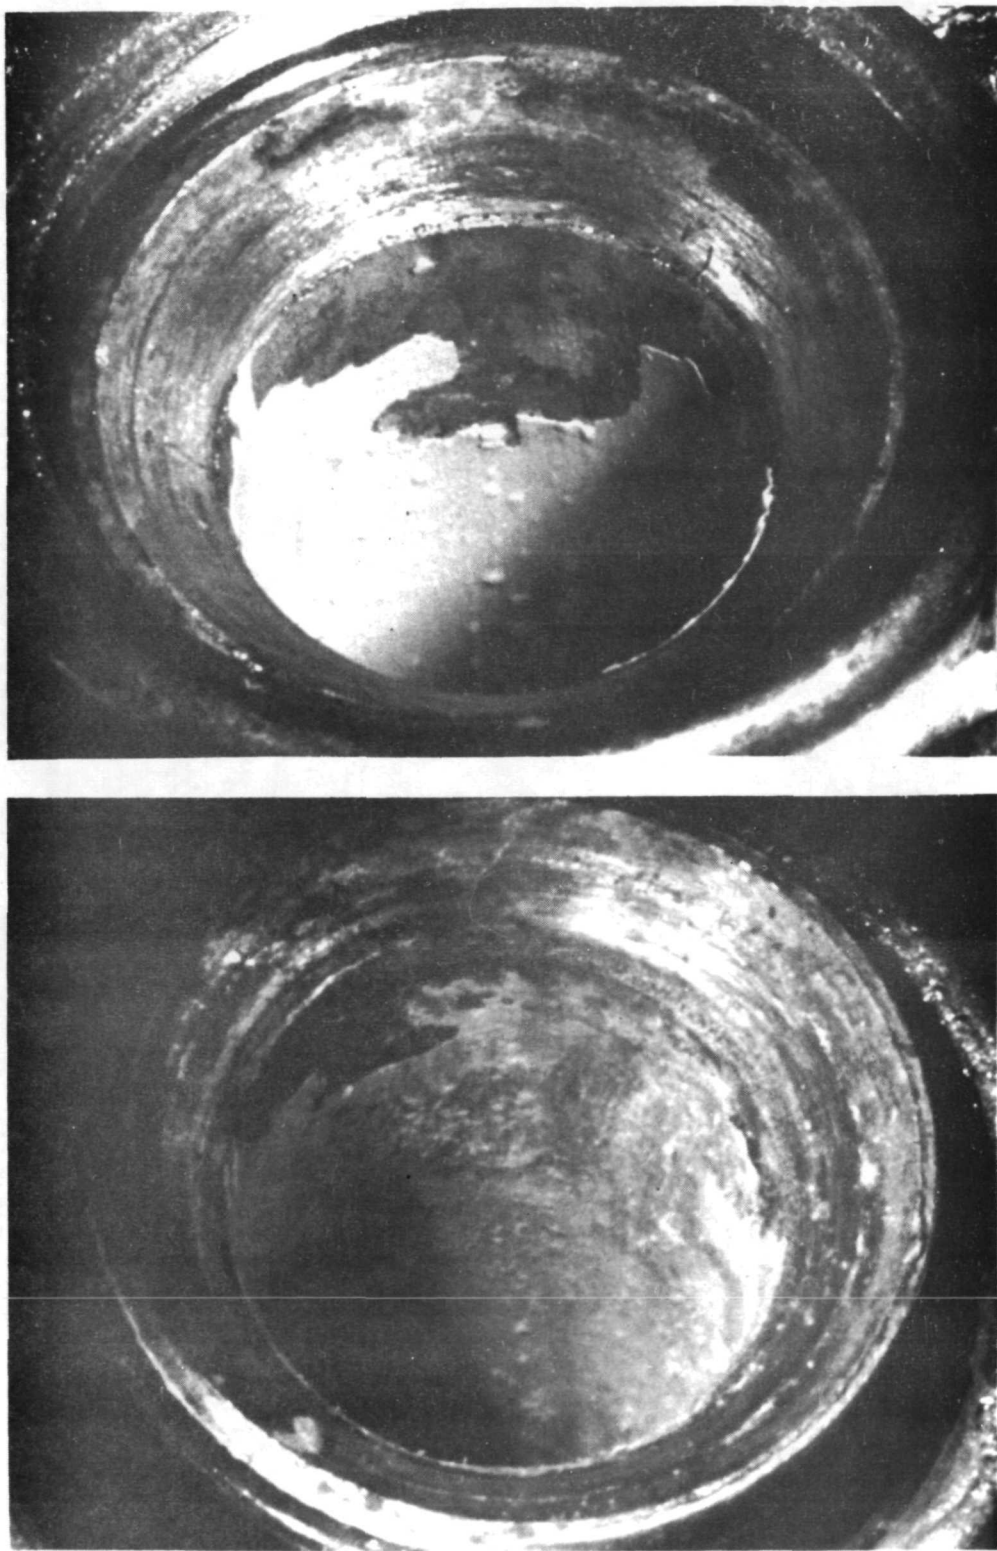
Early in the study, EREP Tape Recorder No. 5 was examined at Ampex as discussed above. This recorder had been in the spacecraft during the time that the first two filters (S/N 9 & 24) had been in the system. An inspection of the cooling tubes (coldplate) was made by JSC, MDAC and Ampex personnel. At the steel/aluminum inlet and outlet connections there was an uneven coating of white flaky contaminant. There was no indication of pitting. A fiberscope was used to inspect a short distance into the aluminum tubing. There was an even coating of white contamination tightly adhered to the surface.

When it became known that stray electrical currents were associated with the tape recorders, the No. 5 tape recorder was again examined. At this time, personnel from MSFC, JSC, Martin, MDAC-E and Ampex participated. The purpose of this examination was to obtain electrical resistance measurements of the recorder coolant lines and fittings, and to inspect the lines and fittings more closely for contamination. Typical results are shown in Figure 4. A drawing of the tape recorder coldplate is shown in Figure 5. The results of this investigation were as follows:

1. Extremely low resistance measurements were found at all stainless steel fitting to aluminum tubing joints. The measurements ranged from 0.06 to 0.95 milliohms, generally they were from 0.1 to 0.2 milliohms.

2. Visual examination was made of about 1.52 meters (5 ft.) of the 4.68 meters (15.35 ft.) of aluminum tubing making up the coldplate.
3. Most of the contamination found was at the inlet and outlet to the recorder (only a few milligrams).

4. Nickel Voishan washers are used only on the inlet and outlet lines of the coldplate. These are used only if the joints leak.
5. A small amount of white powdery coating was found inside all openings, some loose and some tightly adherent. It was more concentrated at fitting joints and tube bends. Deposit thickness was estimated to be 0.005 to 0.01 cm (0.002 to 0.004 inch) thick in some areas.

6. Superficial etching was noted at the interface of the stainless steel to aluminum joints. The etched areas were bright and shiny and appeared to be more than 0.00254 cm (0.001 inch) deep. This was not observed until the deposit was removed by rubbing with a dry cotton swab.

The conclusion drawn from this examination was that this coldplate probably contributed to the contamination problem, but in retrospect it does not appear to have been the only contributor.

FIGURE 4 - CONTAMINATION IN COOLING COIL OF EREP TAPE RECORDER NO. 5

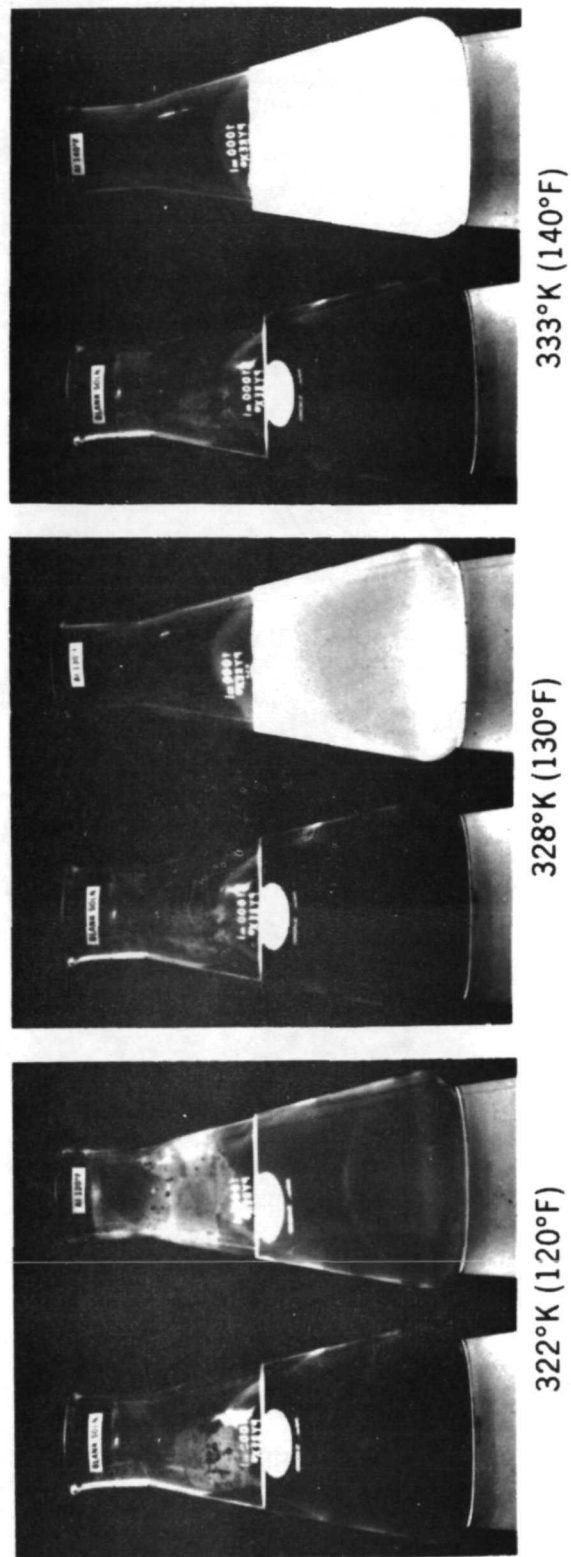
At the conclusion of the test, all of the solutions appeared somewhat opaque. The solution became very milky upon cooling to room temperature

as shown in Figure 6. Table I and Figure 7 give the results of these tests. The spectrographic analysis of the residue from the solution formed at 333°K (140°F) with the aluminum specimens showed the following:

FIGURE 6 - TYPE I SOLUTION HEATED TO VARIOUS TEMPERATURES
FOR 15 HOURS WITH 6061 ALUMINUM SPECIMENS

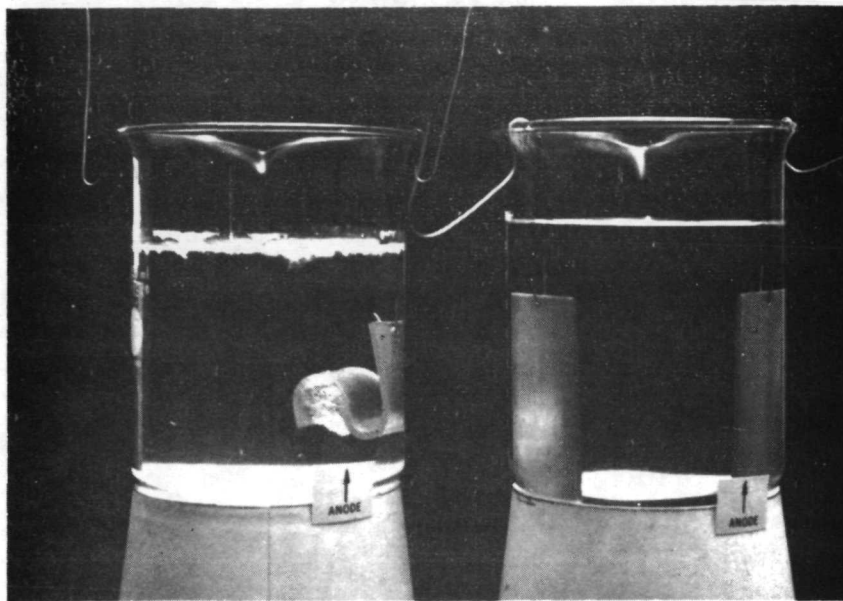
FIGURE 12 - EFFECT OF ELECTRODE LOCATION AND CONFIGURATION ON THE FORMATION OF RESIDUE BY ELECTROLYSIS

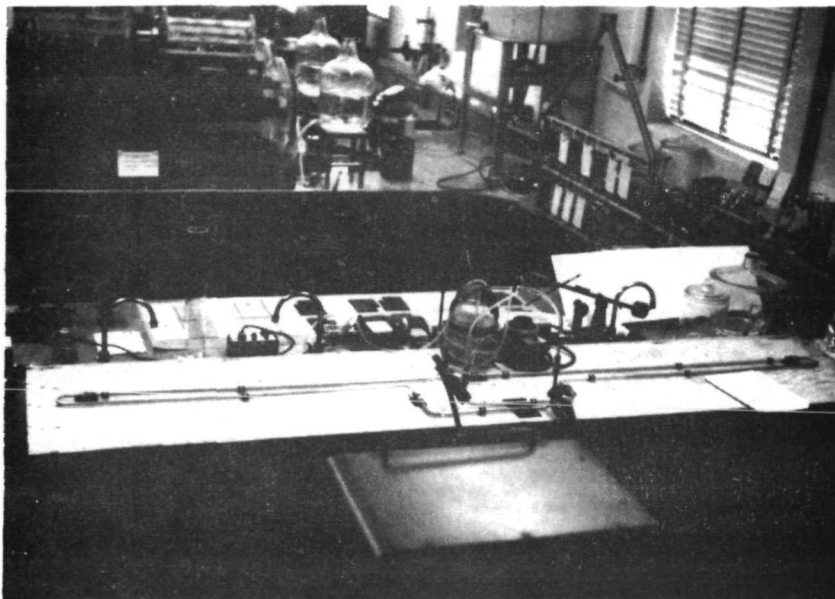
The last part of this series of studies was made on a simulated Tape Recorder Coldplate. The coldplate was fabricated using the same size and type 6061 aluminum tubing (Figure 13), 0.95 cm (3/8 inch) in diameter with a 0.089 cm (.035 inch) wall thickness. The length of 6061 aluminum tubing was 457 cm (180 inches) with 5 stainless steel couplings and 107 cm (42.1 inches) of 304 CRES tubing. The only difference in this coldplate and an actual coldplate was the geometrical configuration.

FIGURE 13 - SIMULATED TAPE RECORDER COLDPLATE
